**FIELD EVALUATION OF DROP-CHECK STRUCTURES  
FOR FARM IRRIGATION SYSTEMS**

**March 1971 ARS 41-180**

Agricultural Research Service

**UNITED STATES DEPARTMENT OF AGRICULTURE**

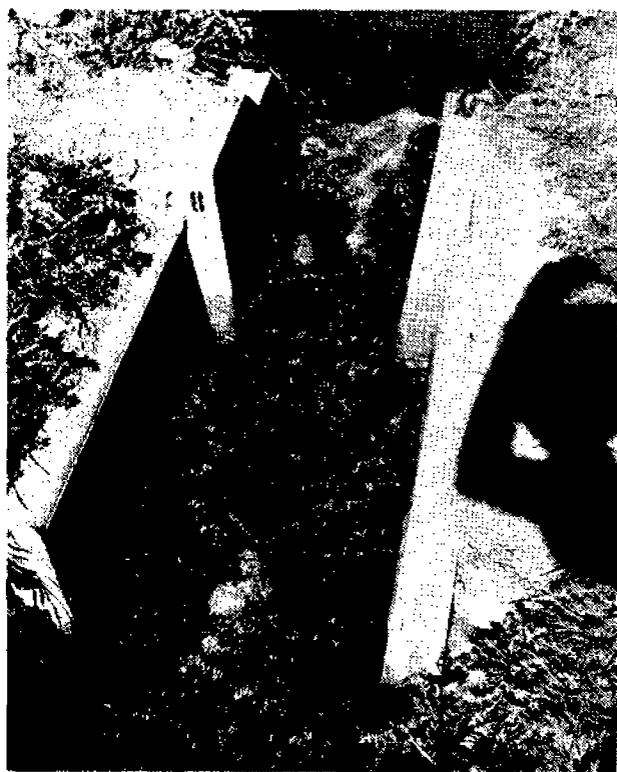
Figure 1.—Photograph showing high-velocity, accelerated flow through the narrow opening of a cofferdam-type structure at 91 percent (1.65 c.f.s.) of design flow.

the narrow opening. A considerable part of the total drop in water surface occurred as the water flowed through this opening rather than in the cofferdam drop. Therefore, the relatively long cofferdam crest was nullified by the contracted opening downstream, and the effective length of the structure was reduced for stilling purposes. Sidewalls were used on structures 27, 28, and 29 to protect the downstream channel banks and to prevent erosion of the sand- and-gravel backfill material next to the structure walls. The sidewalls increased the effective length of the basin; however, the channel bed between the sidewalls was still exposed to high velocities when the structures were operated as drops with low tail-water levels. The sidewalls need to be installed relatively deeply to prevent their being undermined. Gravel or rock placed between them would help protect the bed.

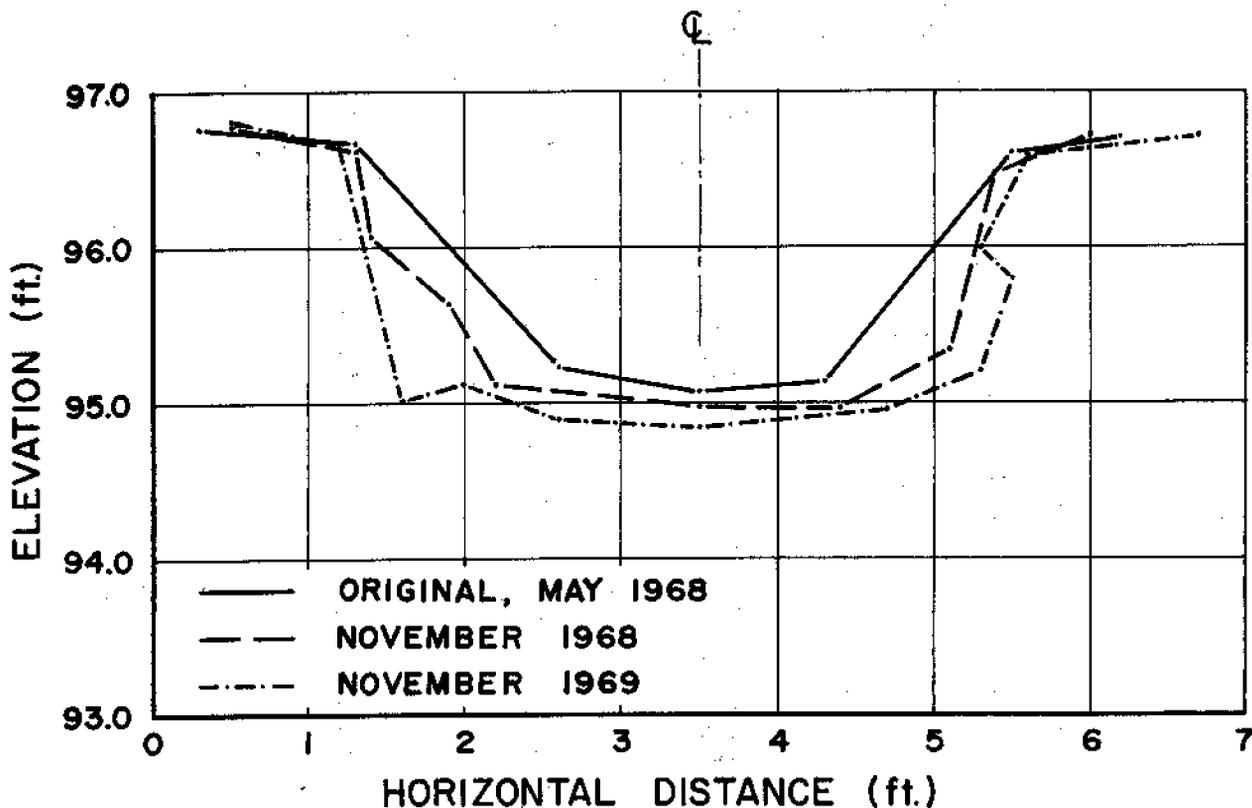
The above data indicate that, during the 2-year period, about 16 percent more total soil loss occurred in the first 2.5 feet downstream from structures having end sills. On the other hand,

Figure 4.—Channel cross section 18 inches below a structure with an end sill, No. 6.

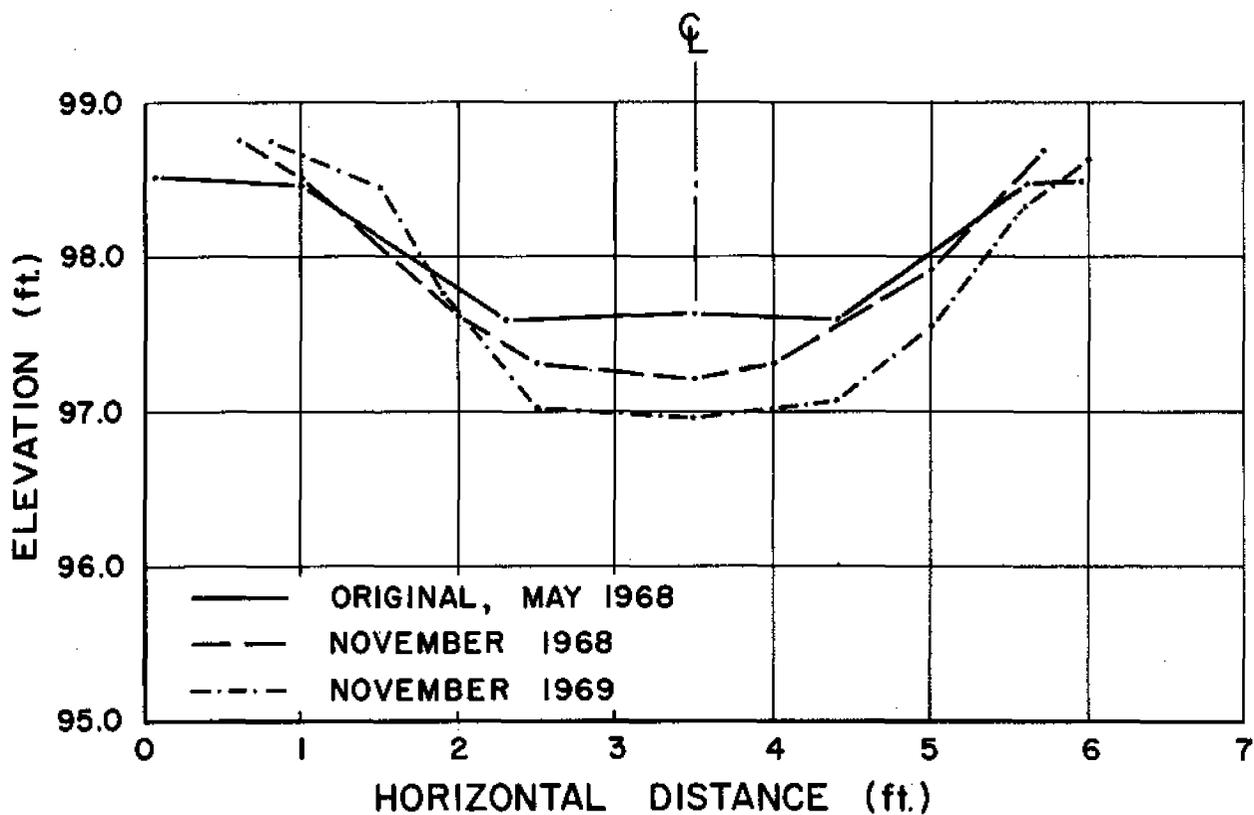
Figure 5.—Channel cross section 18 inches below a structure without an end sill, No. 2.

the data show that the average scour depth downstream from structures without end sills was about 62 percent greater. For those structures without an end sill, there was a direct qualitative relationship between scour volume

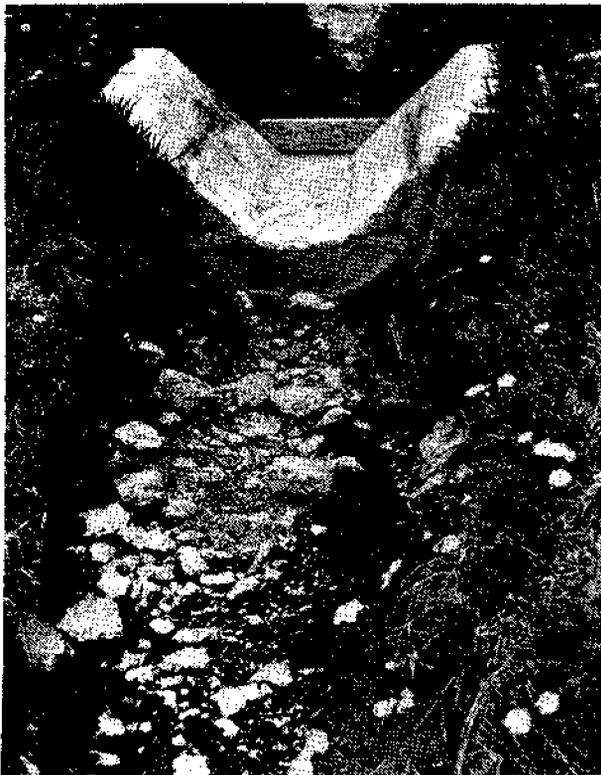
The difference in tailwater depth noted previously between structures 19 and 20 accounts for the large difference in scour depth and erosion volume for these structures, which are of the same design. The difference in scour volume and performance is significant and emphasizes the importance of adequate tailwater depth for this type of structure. Channel degradation below structure 19, which had shallow tailwater, is shown in figure 8.

Figure 8.—Channel degradation below a trapezoidal structure that operated with a very shallow tailwater depth.

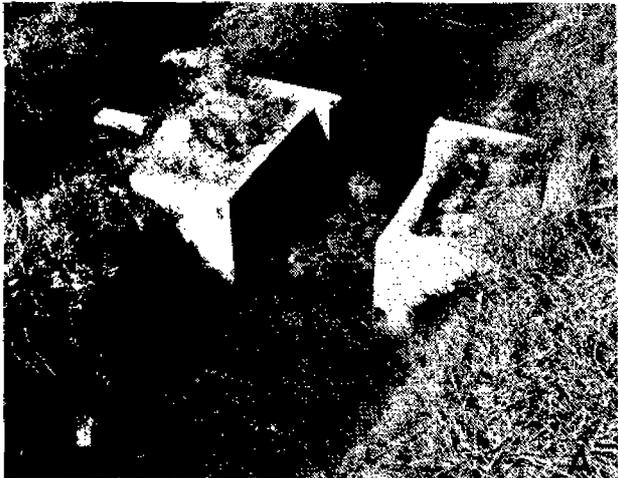
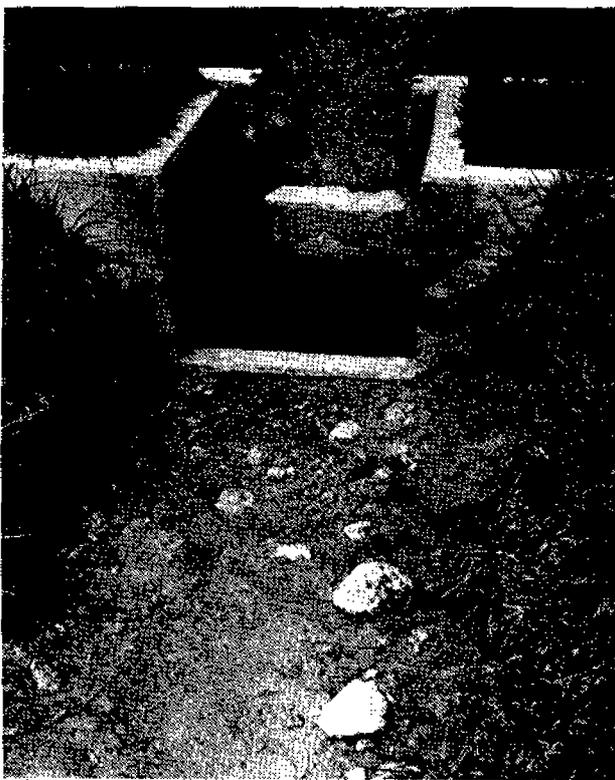
Figure 12.—Standard design, cast-in-place concrete, rectangular-basin structure with an end sill, Nos. 4, 5: A, In operation. B, At the end of the study.

Structure 5: Vertical crack in wingwall.

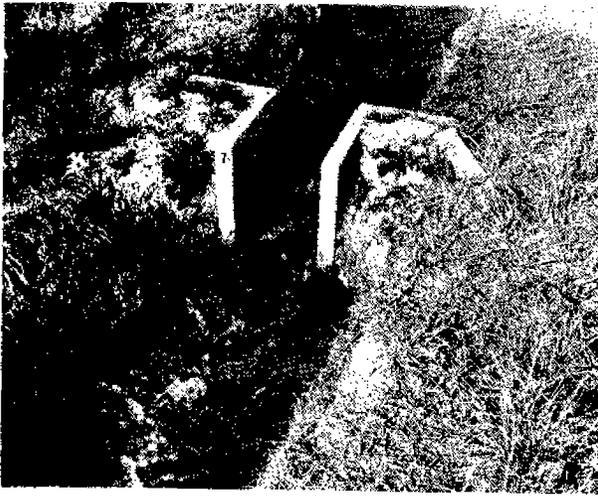
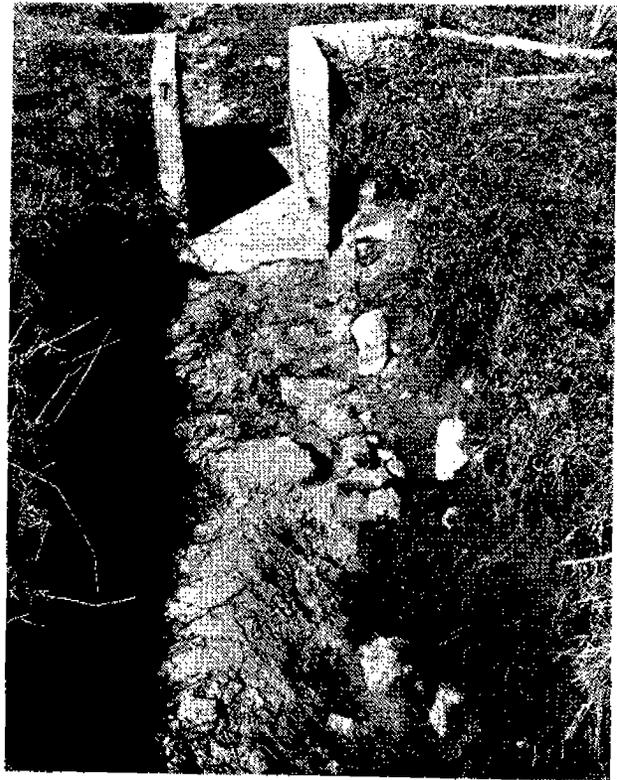
Figure 14.—Precast concrete structure without an end sill, Nos. 7, 18: A, In operation. B, At the end of the study.

Structure 7: Longitudinal cracking in the corners of the basin at the base of the sidewalls.

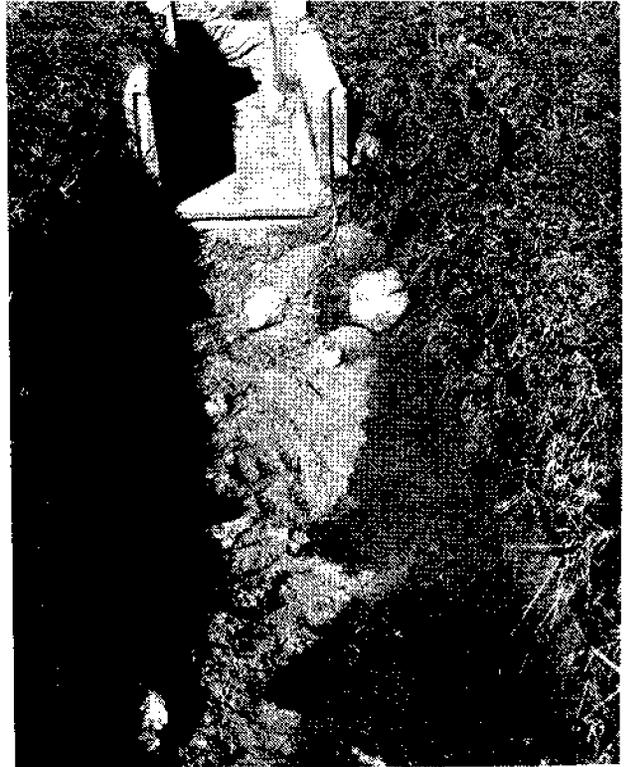
Figure 15.—Small-size precast concrete structure with upstream cofferdam and downstream liner section, Nos. 8, 9, 10: A, In operation. B, At the end of the study.

Structures 8, 9, and 10: Cracking and spalling on the top of the center section.

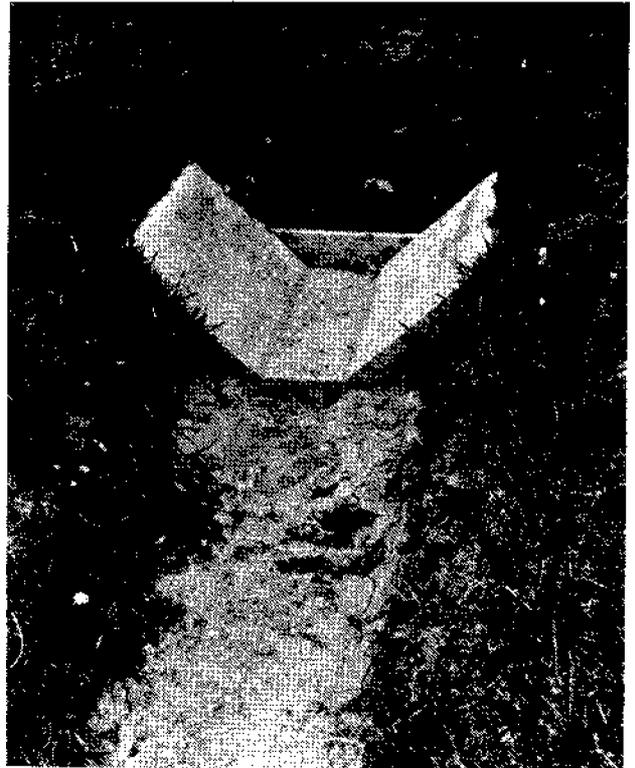
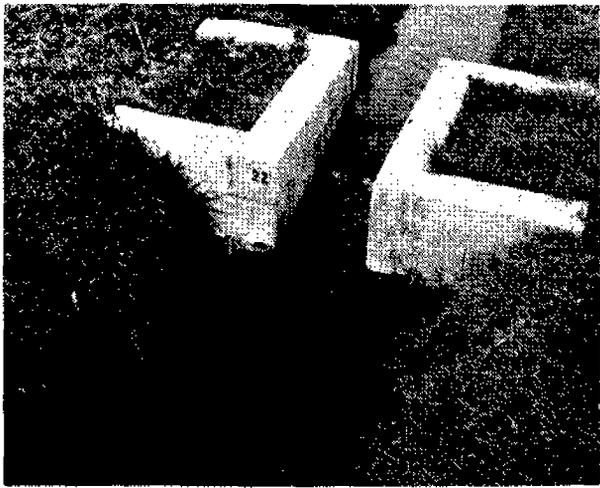
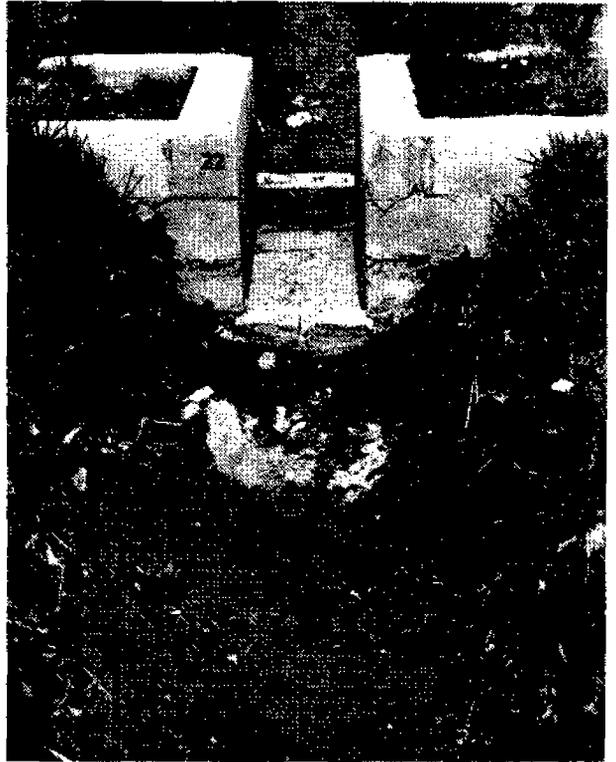
Figure 20.--Standard design, concrete-block structure with rectangular basin, Nos. 21 and 22: A, In operation. B, At the end of the study.

Structure 21: Block cracking, some joint separation and longitudinal block cracking near the base of the concrete-block sidewalls.

Structure 22: Block cracking, some joint separation and longitudinal block cracking near the base of the concrete-block sidewalls, transverse cracking of the basin floor at each end, separation of the basin floor from the sidewalls, and end-sill break.

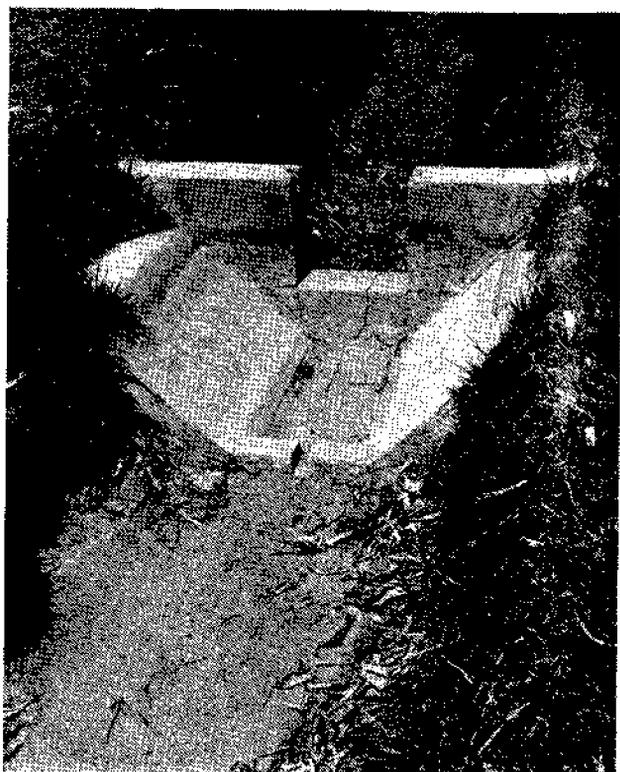
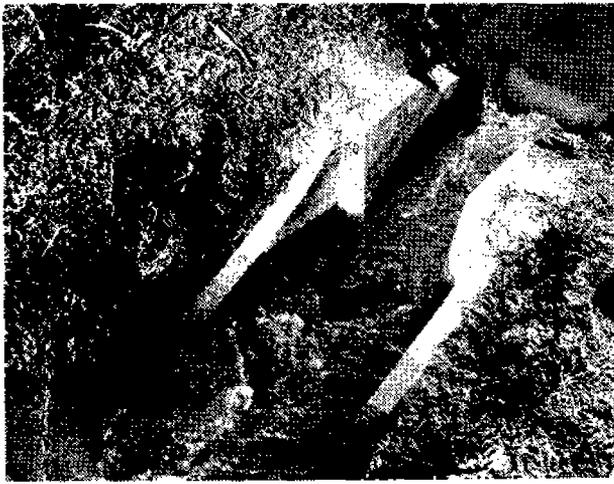
Figure 24.—Large-size, precast concrete structure with upstream cofferdam and downstream sidewalls, Nos. 27, 28, and 29: A, In operation. B, At the end of the study.

Structures 27, 28, and 29: Concrete spalling on the downstream face of the cofferdam.

Because of the loosened soil condition following installation, the prefabricated structures were more subject to damage from streamflow overtopping than those constructed in place. Structures are usually designed with enough freeboard that overtopping is not a problem. During a period of high flow (2.98 c.f.s.) in 1967, structures 27 and 29 were partly washed out when they were overtopped while

being operated with their mated check boards adjusted to check the water 6 inches. If overtopped, these structures are subject to failure because of the erodibility of the sand and fine gravel backfill mix. Unusually large flows, however, are not common in well-regulated systems. When the cofferdam structures are used as checks, the check boards must be removed from the bottom structures first to prevent water "pileup" and overtopping by the large flows that would otherwise occur.

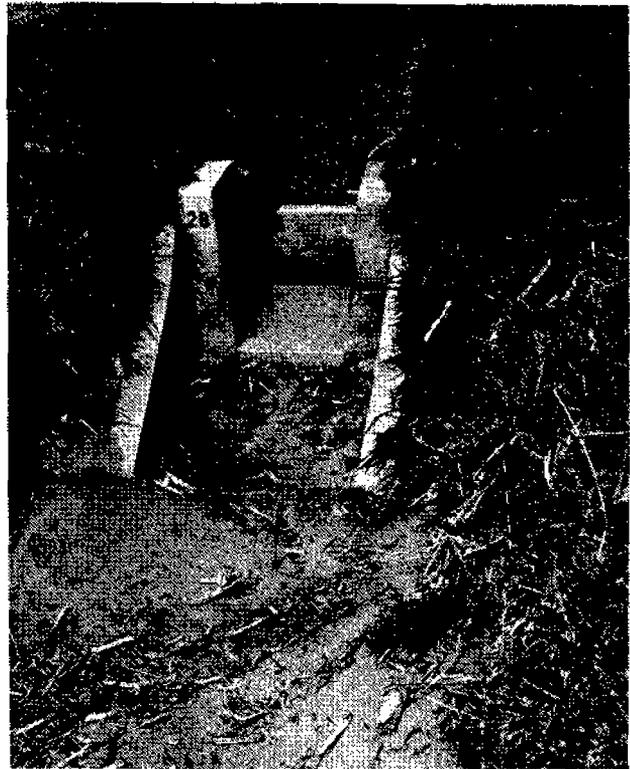
Figure 25.—Commercial, modular aluminum structure, local design, No. 30: A, In operation. B, At the end of the study.

out failure initiated by piping was experienced with structure 30. The headwall panels on one side of the structure were not driven deep enough and this, combined with erosion from the downstream side, caused failure.

The stilling basins for metal modular structures 24 and 30 were too short to provide adequate energy dissipation. The apron of structure 30 was extremely short, and strong turbulence occurred downstream over the unprotected soil; however, an apparent hardpan in this area reduced the scouring. This structure was designed and installed by the local dealer as it is normally used in the area. Consequently, the apron was very short and wingwalls were not provided. Erosion occurred beneath the basin and behind the sidewalls extending upstream to the headwall. This caused the structure to fail by undermining one side of the headwall. A construction flange at the end of the basin on the bottom and sides of structure 24 appeared to contribute to the formation of eddy currents similar to those at the end of structure 23. Vortices and eddy currents tended to form at the downstream corners of all basins having 90° wingwalls, but they were stronger and more pronounced with basins having sills and protruding flanges. Be-

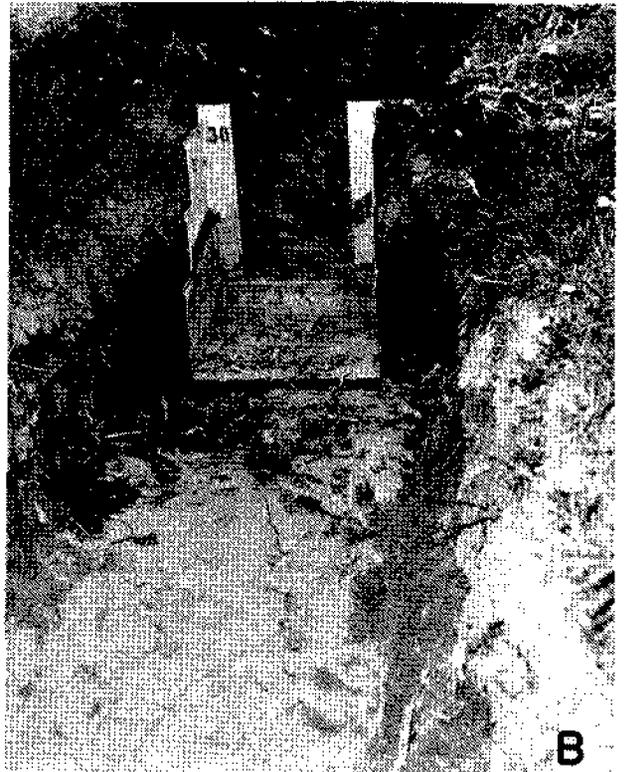
Figure 26.—Standard design wooden structure, No. 31:  
A, In operation. B, At the end of the study.

After the study was initiated, a culvert was installed downstream from structure 31. This resulted in an increased tailwater depth, and the structure operated partly submerged except when the flow was very small. Even though partly submerged much of the time, the narrow basin, combined with turbulence over the end sill, caused considerable erosion and stream channel widening immediately downstream.
