Evaluation of Drop-Check Structures for Farm Irrigation Systems

A. S. Humpherys

ABSTRACT

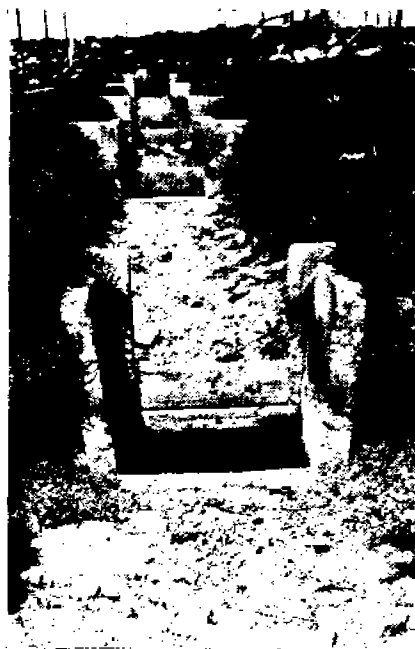
Fig. 7—Channel downstream from precast structure No. 6 illustrating bank undercutting and erosion caused by end sill-induced turbulence at low tailwater depths.

bottom by directing high velocity flows away from the bottom of the channel. However, with low tailwater depths, the water cascaded over the sills and caused increased turbulence immediately downstream. This tended to cause lateral flow which impinged upon the sides of the ditch and resulted in undercutting and erosion of the banks. Short basin lengths aggravated the condition as shown in Fig. 7. This adverse effect can be minimized or overcome by placing the basin and end sill below grade so as to increase tailwater depths.

6. With low tailwater depths, end sills generally caused turbulence which undercut and eroded the ditch banks immediately downstream. Sill heights from 5 to 10 cm were the most effective and are recommended. The top of these low sills should be installed below grade to provide 15 to 30 cm water depth on the apron for drop heights up to 30 cm and design flows in the 110 to 140 L/s range. End sill turbulence for higher sills can be contained within the basin by installing the sill a short distance upstream from the end of the basin; however, this may require a longer basin length.
