**FIELD EVALUATION OF DROP-CHECK STRUCTURES  
FOR FARM IRRIGATION SYSTEMS**

**March 1971 ARS 41-180**

Agricultural Research Service

**UNITED STATES DEPARTMENT OF AGRICULTURE**

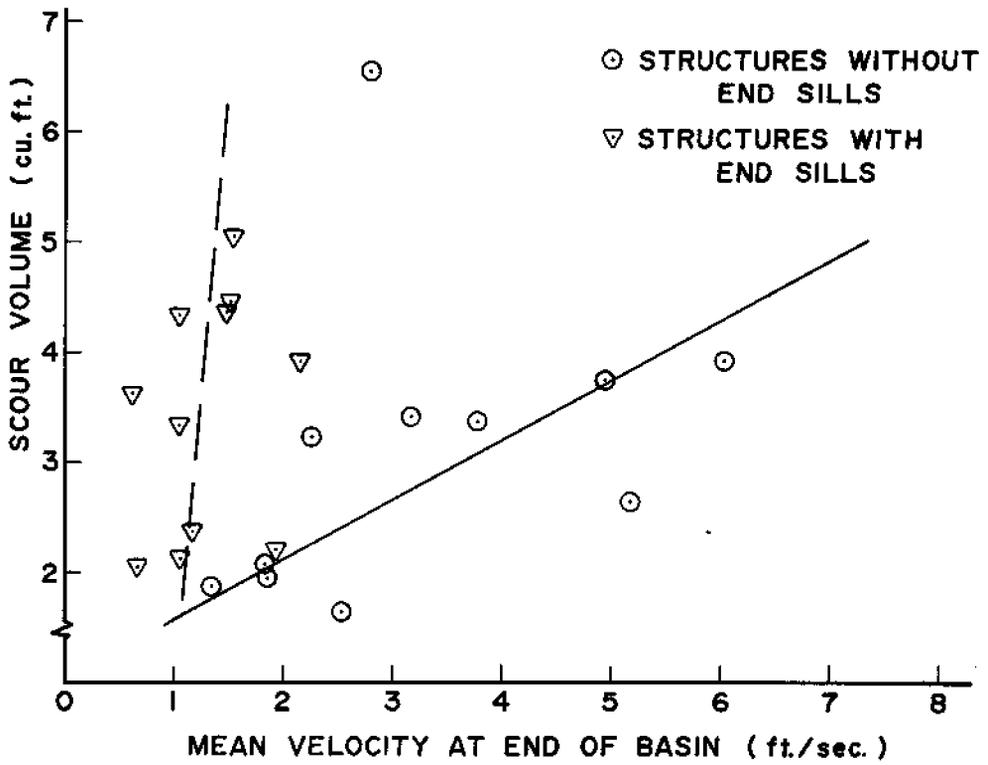
and the average velocity at the end of the basin, as represented by the average velocity measured with a flow of 1.4 c.f.s., shown in figure 7. Scour volume and average velocity at the end of the basin for structures that had end sills were only slightly related.

Figure 7.—Qualitative relationship between scour volume and average velocity at the end of the basin for structures with and without end sills. The average velocity shown is that measured with a flow of 1.4 c.f.s.

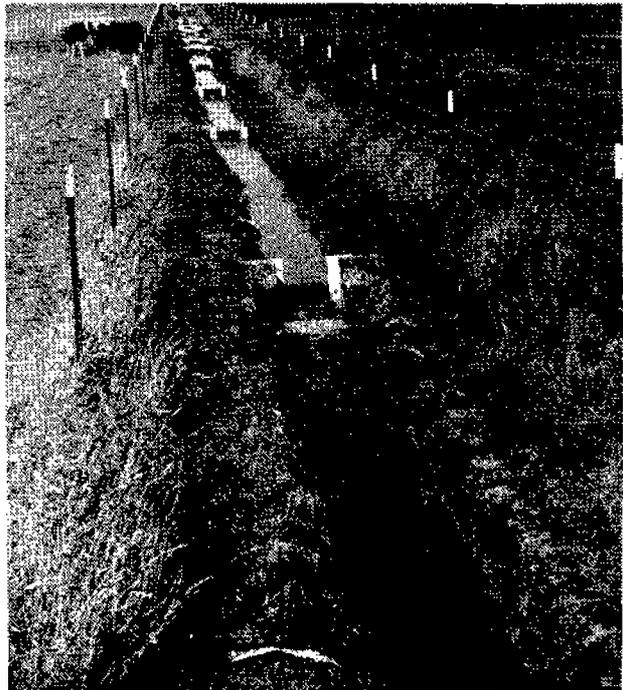
Figure 10.—General view of downstream section of ditch looking upstream from structures 30 to 19.

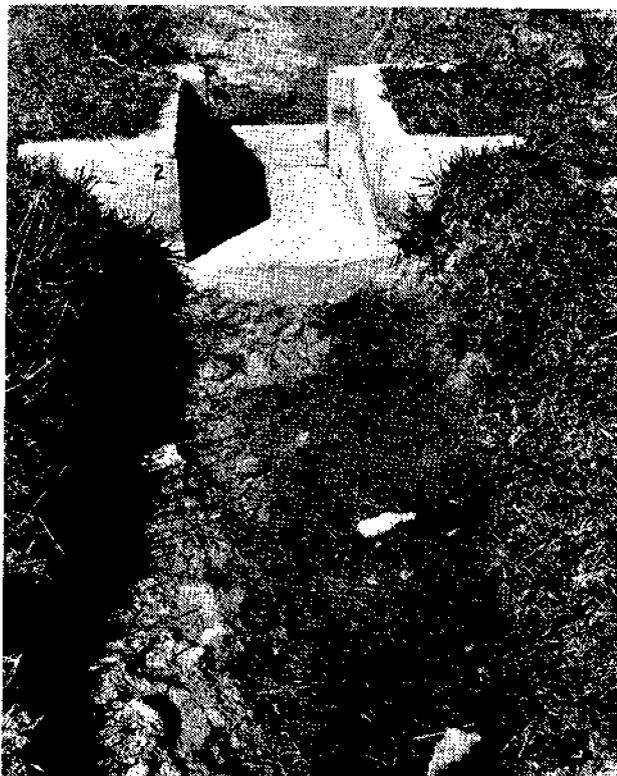
Figure 11.—Standard design, cast-in-place concrete, rectangular-basin structure without an end sill, Nos. 2, 3: A, In operation. B, At the end of the study.

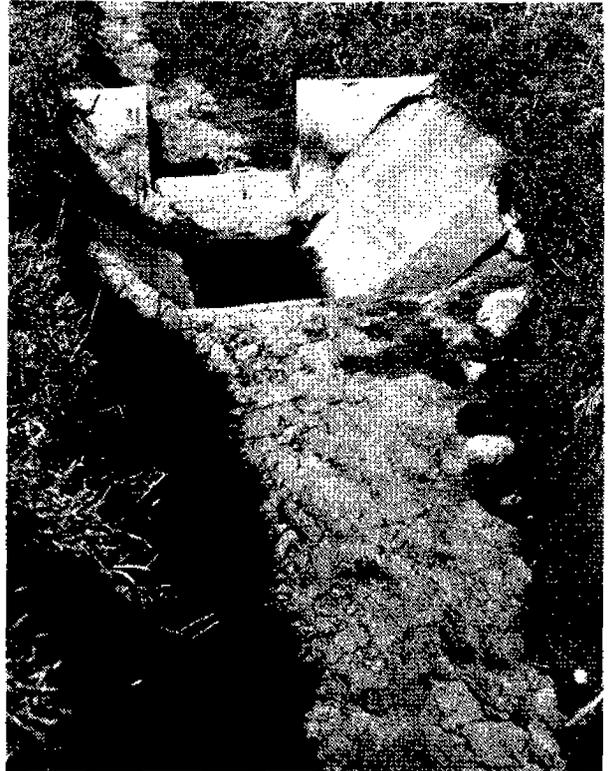
Figure 16.—Precast concrete-headwall structure with fiber glass stilling basin, Nos. 11 and 12: A, In operation. B At the end of the study.

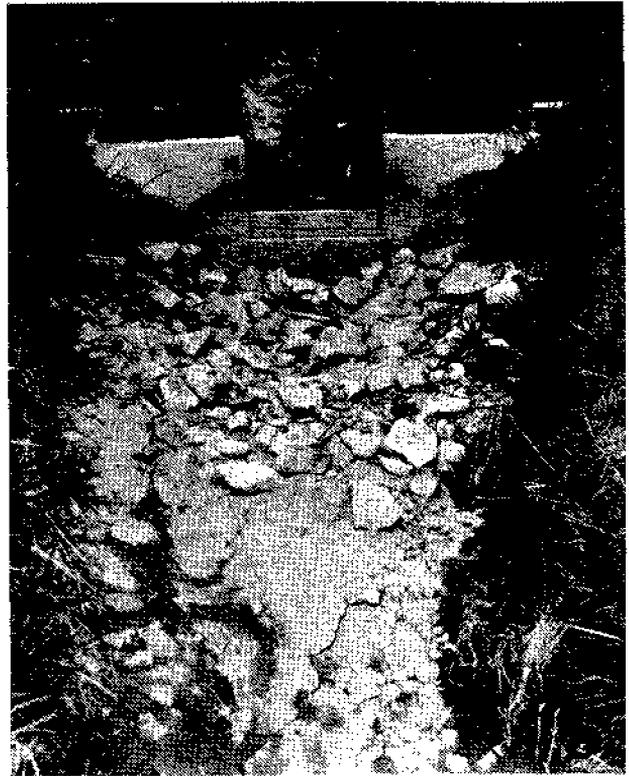
Figure 18.—Precast concrete-headwall structure with small-riprap stilling basin, Nos. 1, 15, and 16: A, In operation. B, At the end of the study.

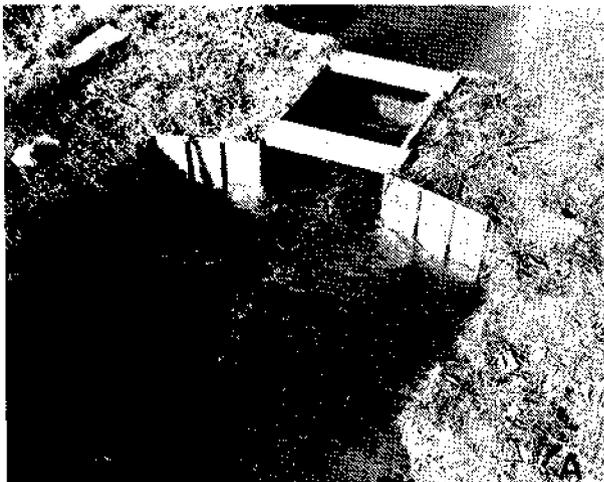
Metal modular structure 23 (see Appendix, fig. 21) originally had a narrow opening and a narrow stilling basin. At the beginning of the 1968 season, it was removed and rebuilt to provide a wider and longer basin with a longer crest. The scour hole that had developed downstream during the first two seasons was filled. Extending the crest length and basin width did not entirely correct its faulty performance. Flanges on the vertical edges of the modular components protruded into the stream and apparently altered the pressure distribution near the end of the basin. At some discharges, the water was observed to flow almost 90° laterally at the downstream end of the structure. The high end sill in structure 23 also appeared to contribute to strong turbulence, which persisted even with an increased tailwater depth. Because of the lateral velocity currents, considerable erosion and channel widening continued downstream after the original scour hole was refilled. This structure washed out several times during the course of the study, and considerable maintenance was required around the ends of the wingwalls.

Figure 21.—Commercial, modular-steel structure with water checked to give increased tailwater depth, No. 23: A, In operation. B, At the end of the study.

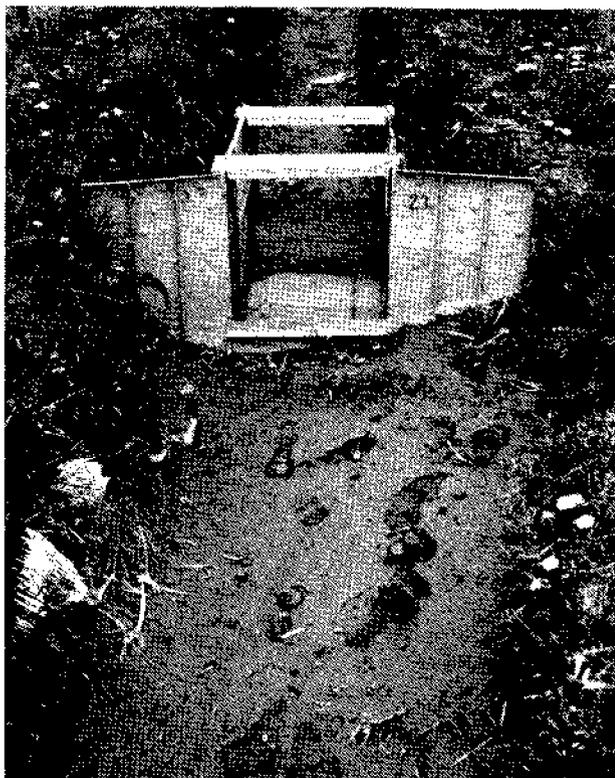
Erosion upstream from the crest of most structures was observed. This was sometimes attributed to the loosened condition of the soil during installation. However, erosion also occurred upstream from the crest of structures 24 and 30, where metal modules or panels were

Figure 22.—Commercial, modular-aluminum structure, special design, No. 24: A, In operation. B, At the end of the study.

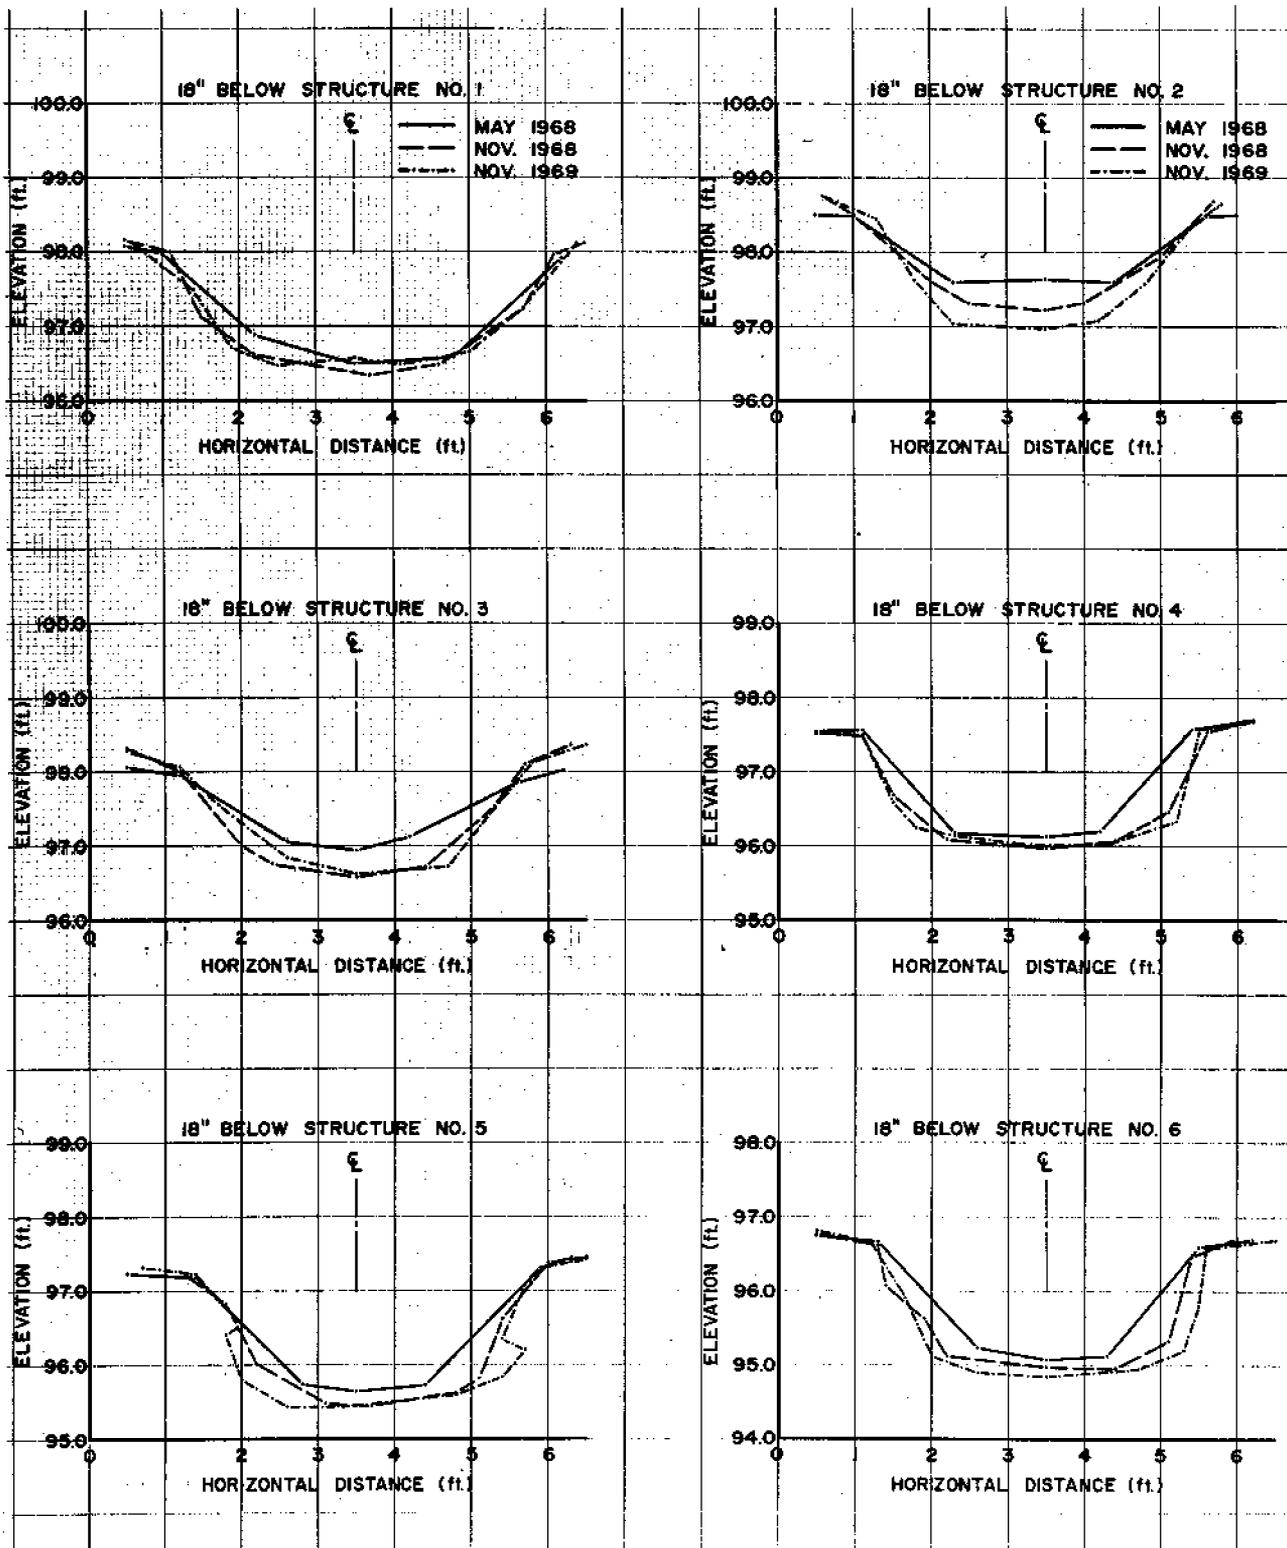
Figure 27.—Channel cross sections 18 inches downstream from structures 1 to 6.

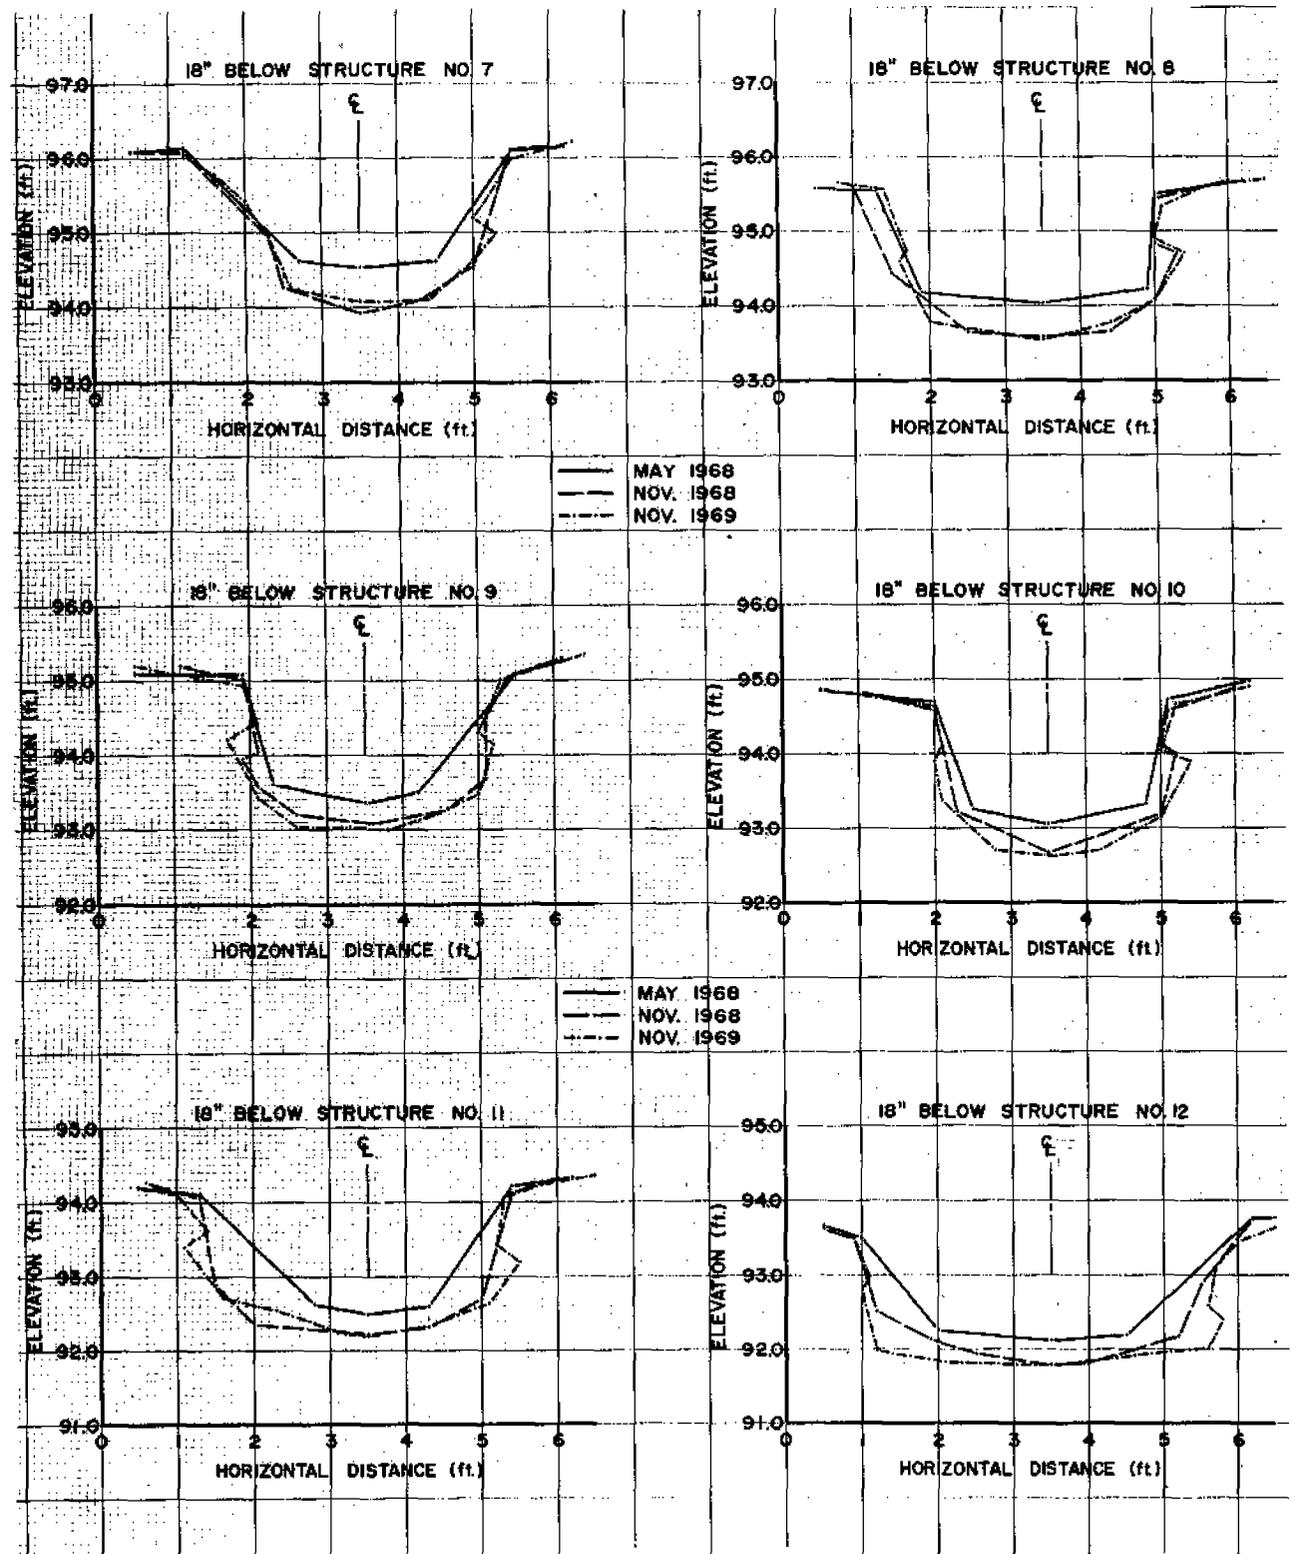
Figure 28.—Channel cross sections 18 inches downstream from structures 7 to 12.

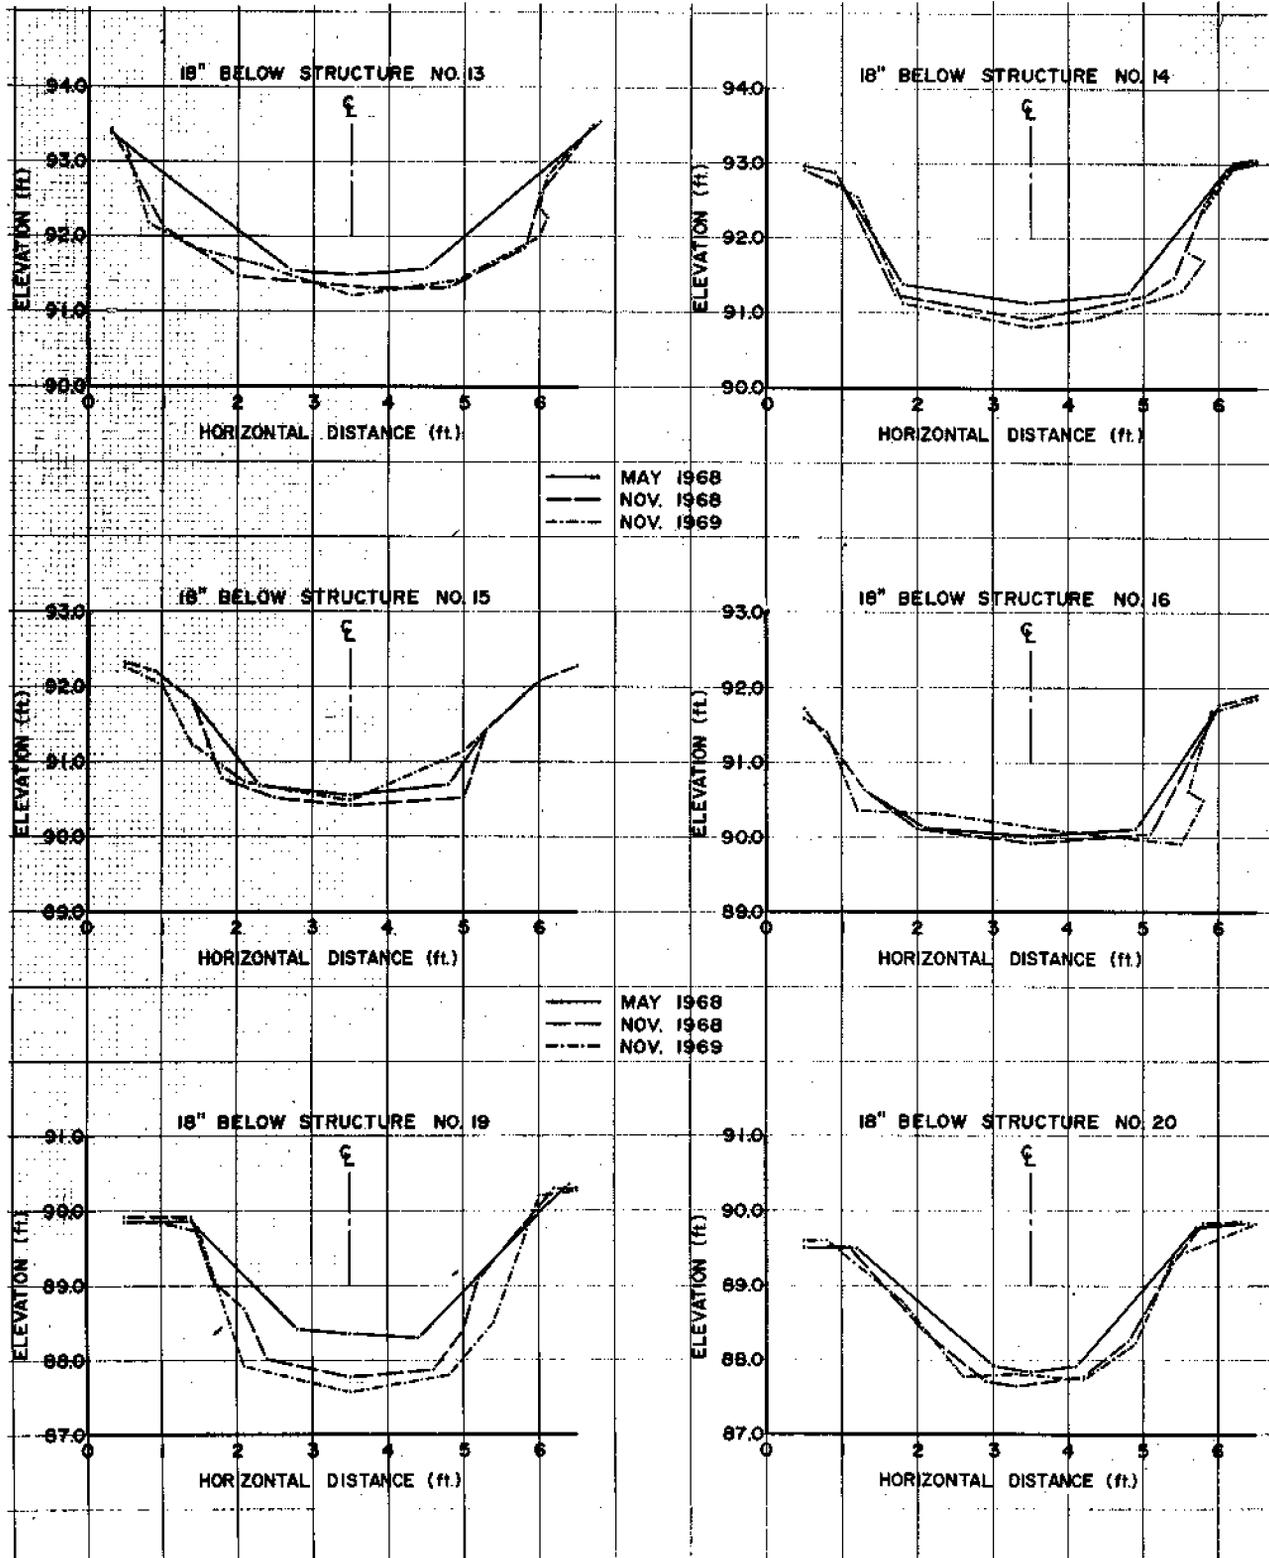
Figure 29.—Channel cross sections 18 inches downstream from structures 13 to 20.

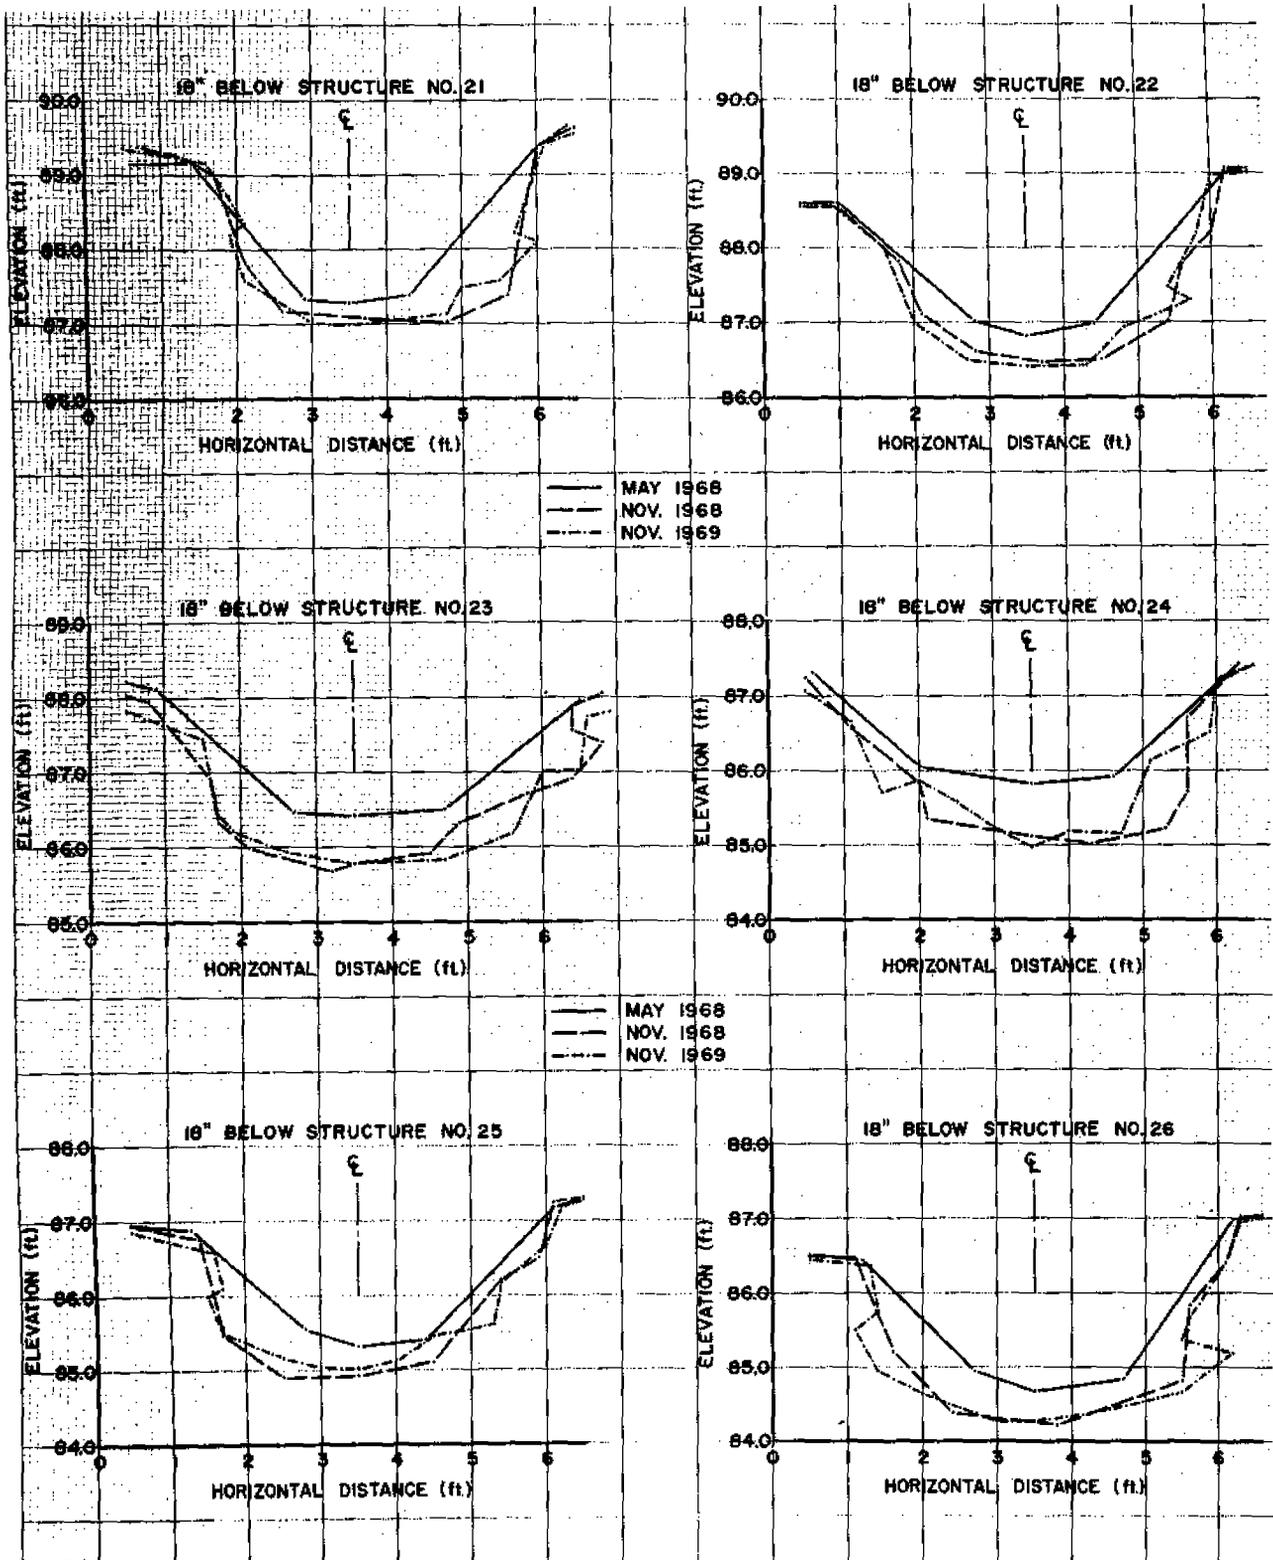
Figure 30.—Channel cross sections 18 inches downstream from structures 21 to 26.

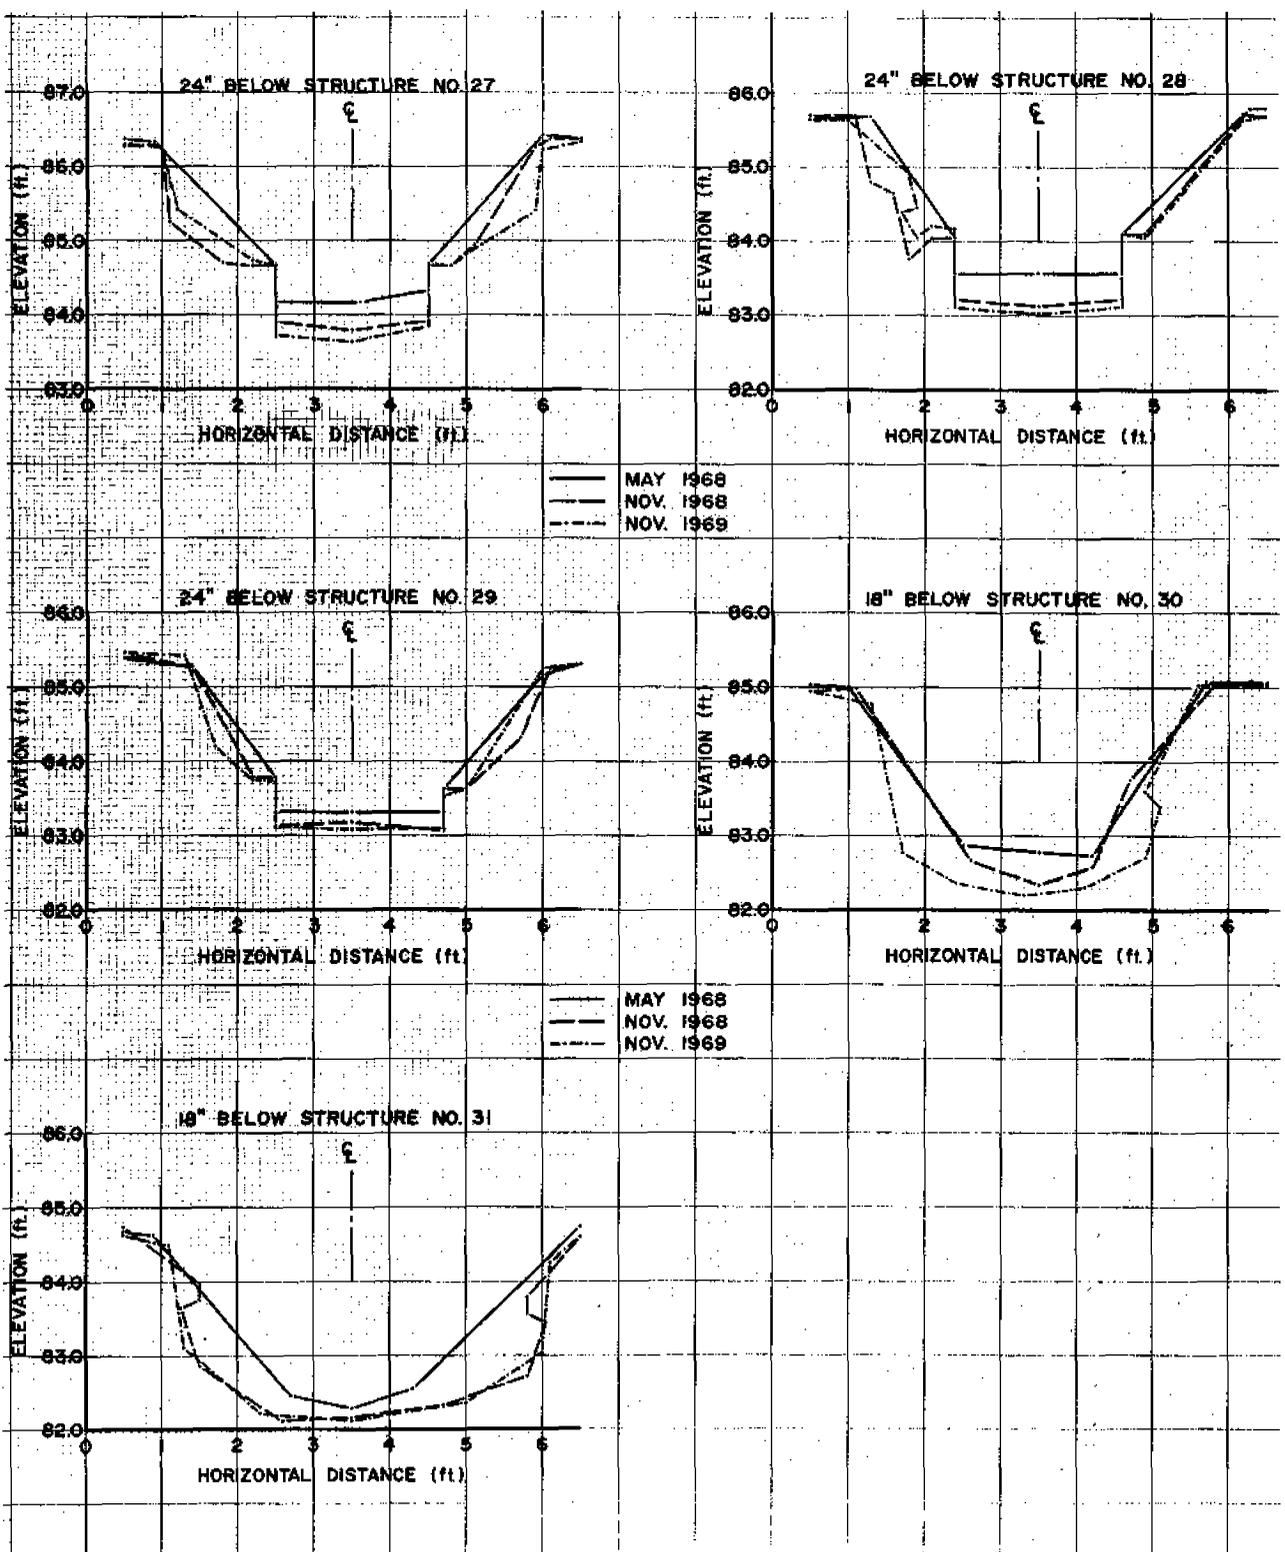
Figure 31.—Channel cross sections 18 inches downstream from structures 27 to 31.
