Evaluation of Drop-Check Structures for Farm Irrigation Systems

A. S. Humpherys

ABSTRACT

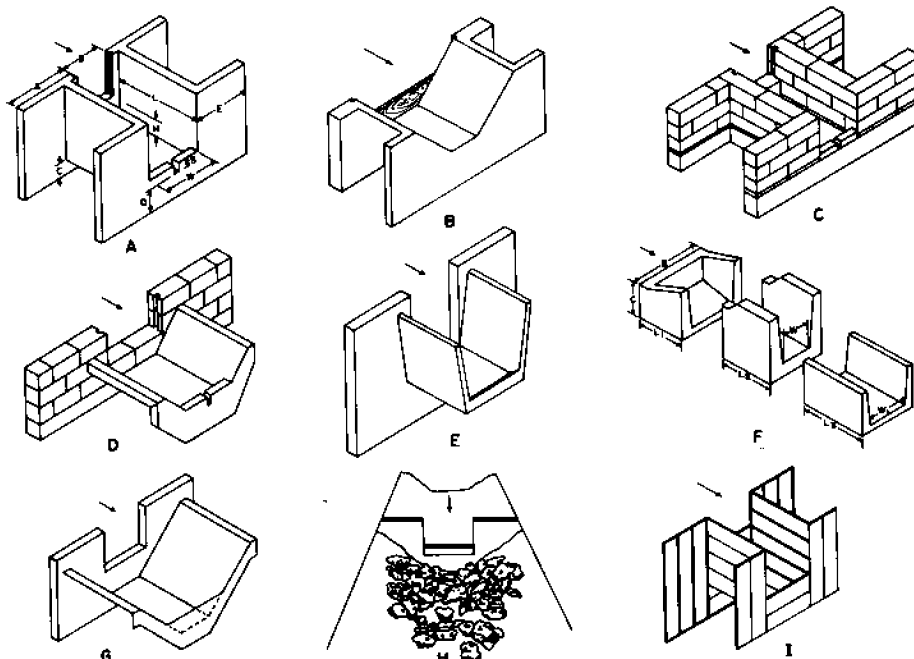
Fig. 1—Schematic drawings showing general configurations of the structures tested.

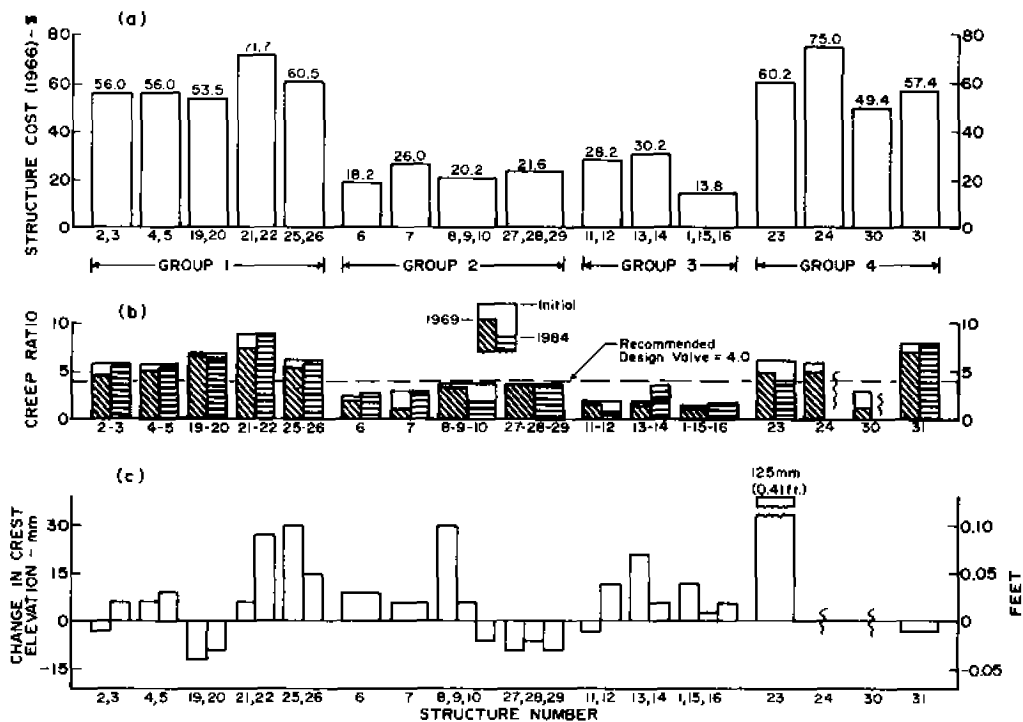
Fig. 2—(a) Structure costs, (b) changes in average creep ratios since 1969, and (c) elevation changes since 1969.

Creep ratios at the beginning of the study were the same for each structure of a pair (or trio) for a given design, and are shown graphically in Fig. 2b for a seepage head of 15 cm (6 in.). Changes in the average ratio for each pair, or structure design, from its initial value for the 1969 and 1984 evaluations are also shown in Fig. 2b. The ratios have not changed significantly since 1969, and in most cases, increased slightly because sedimentation replaced some of the soil that had eroded from around the structures earlier. As shown in Fig. 2b, all of the precast structures have low creep ratios of less than 4.0 and all but the cofferdam structures and structure No. 6 washed out at least once during the initial study period. The failures occurred early in the study by piping around the ends of the headwalls before the soil became fully consolidated and stabilized by vegetation. Much of the piping was caused by rodent holes. None of the headwalls have completely washed out since; however, water is flowing beneath the headwall of No. 12 which has lost its fiberglass stilling basin.

Changes in crest elevations since 1969 were determined to detect structure movement and are shown graphically in Fig. 2c. Approximately one-third of the structures settled while the other two-thirds were higher. There was not a consistent correlation between structure type and elevation changes. Two of the precast structures

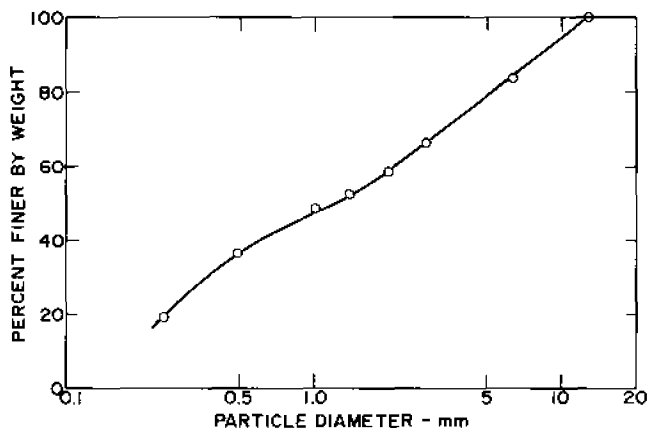
The cofferdam structures were installed with a slurry type backfill mixture of sand and fine gravel adjacent to the structure which discouraged rodent activity. However, the mixture was easily eroded by flowing water such as would occur if a structure were overtopped. The particle size distribution for this material, determined from a sample taken in 1984, is shown in Fig. 5. Since 1969, some sections of the cofferdam structures have settled and tilted such that cracks have developed between the precast sections. This has allowed water to erode the backfill material so that piping and further differential settling has occurred.

Fig. 5—Particle size distribution curve for puddled sand-gravel backfill mix used around cofferdam structures.

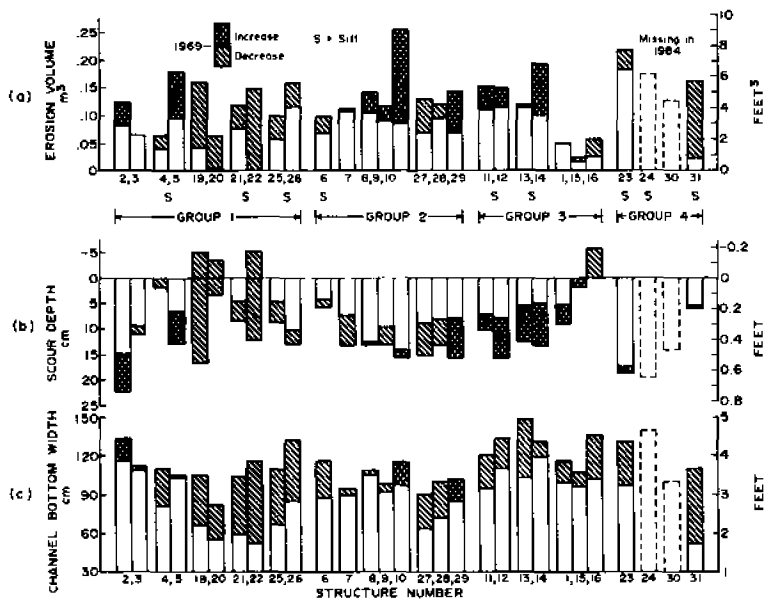
Fig. 9—Changes in (a) downstream erosion volume, (b) scour depth, and (c) channel width in 1984 compared to 1969 values for the drop/check structures tested.

short crest length which resulted in greater flow depths on the apron of structure No. 20. The superior performance of structure No. 20 with its greater tailwater depths, compared to No. 19 with shallow depths, can be seen in the erosion volumes and scour depths shown in Fig. 9a and 9b for the 1969 evaluation, before sedimentation occurred. This effect was also observed with structures 2 and 5 in 1984. A narrow piece of the checkboard in structure No. 3 was all that remained in place while the checkboard for structure No. 6 was completely missing. This lowered the upstream water surface elevations and reduced tailwater depths at structures 2 and 5. It also caused the sill of No. 5 to act as a drop. As noted in Fig. 9, both the erosion volume and scour depths increased for structures 2 and 5, which had shallow tailwater depths. This also partially explains the erosion volume and scour depth increase for structure No. 10 since the checkboard in No. 11 was also missing.

Channel cross-section measurements were made between 30 cm (6 in.) and 150 cm (30 in.) downstream from the structures. The erosion volume in 1969 and volume changes since 1969 (the volume of soil eroded from or added to the measured channel section) are shown graphically in Fig. 9a. Average scour depths and channel widths in 1969 and subsequent changes to 1984 are shown in Fig. 9b and 9c. Because of smaller average stream sizes and poor channel maintenance, sedimentation occurred in the lower ditch section between structures 19 and 31. Thus, the erosion volume and channel widths below these structures were generally less than in 1969. Erosion downstream from structure No. 29 increased because of high exit velocities which were aggravated by the sidewalls which sloughed into the ditch and contracted the flow. Scour depths generally decreased in the downstream section and were variable in the upstream section. It was difficult to relate structure performance to the 1984 channel cross section
