S. Humpherys is an agricultural engineer, Snake River Conservation Research Center, Kimberly, Idaho.

Low-cost sand and gravel separator

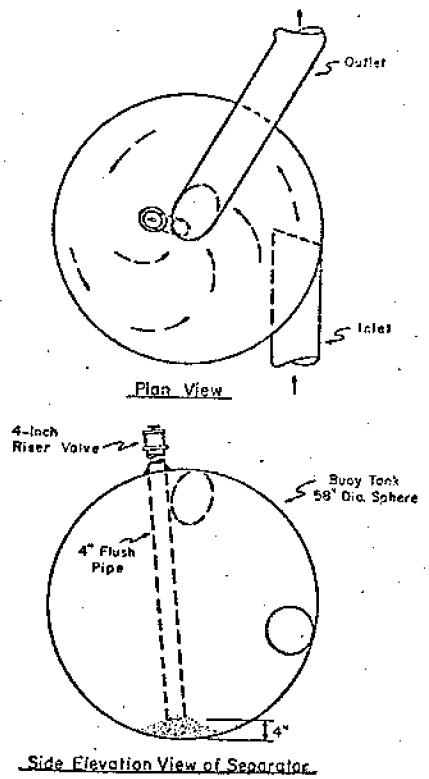
Utah is \$125. Other suitable cylindrical tanks may be available in some areas at a nominal cost. The head loss through the tank is small and in most cases can be neglected. The tank can be buried as shown in the second photo so that it is out of sight, and except for periodic flushing, out of mind also.
