Effect of grain straw and furrow irrigation stream size on soil erosion and infiltration

M. J. Brown

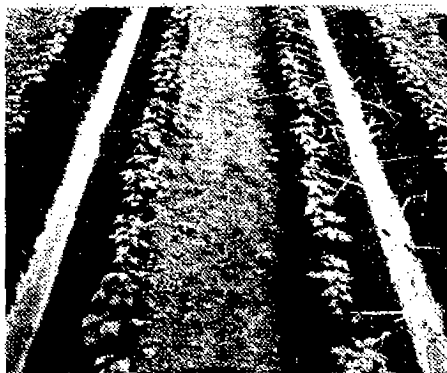
Figure 2. The wetting front of a straw and no-straw furrow after 6 hours of a 12-hour irrigation.

Farmers consider a dry bean crop adequately irrigated when the wetting front moves only a few inches beyond the plant row. In this study the straw furrows appeared to have been wetted adequately after 6 hours of irrigation (Figure 2). However, a 12-hour irrigation was required to wet the no-straw furrows adequately. After a 10-hour irrigation, about 50% more water infiltrated in the straw-treated furrows than in the untreated furrows.
